**Rosewall Creek Restoration Workshop – Photo Record – March 31, 2017**

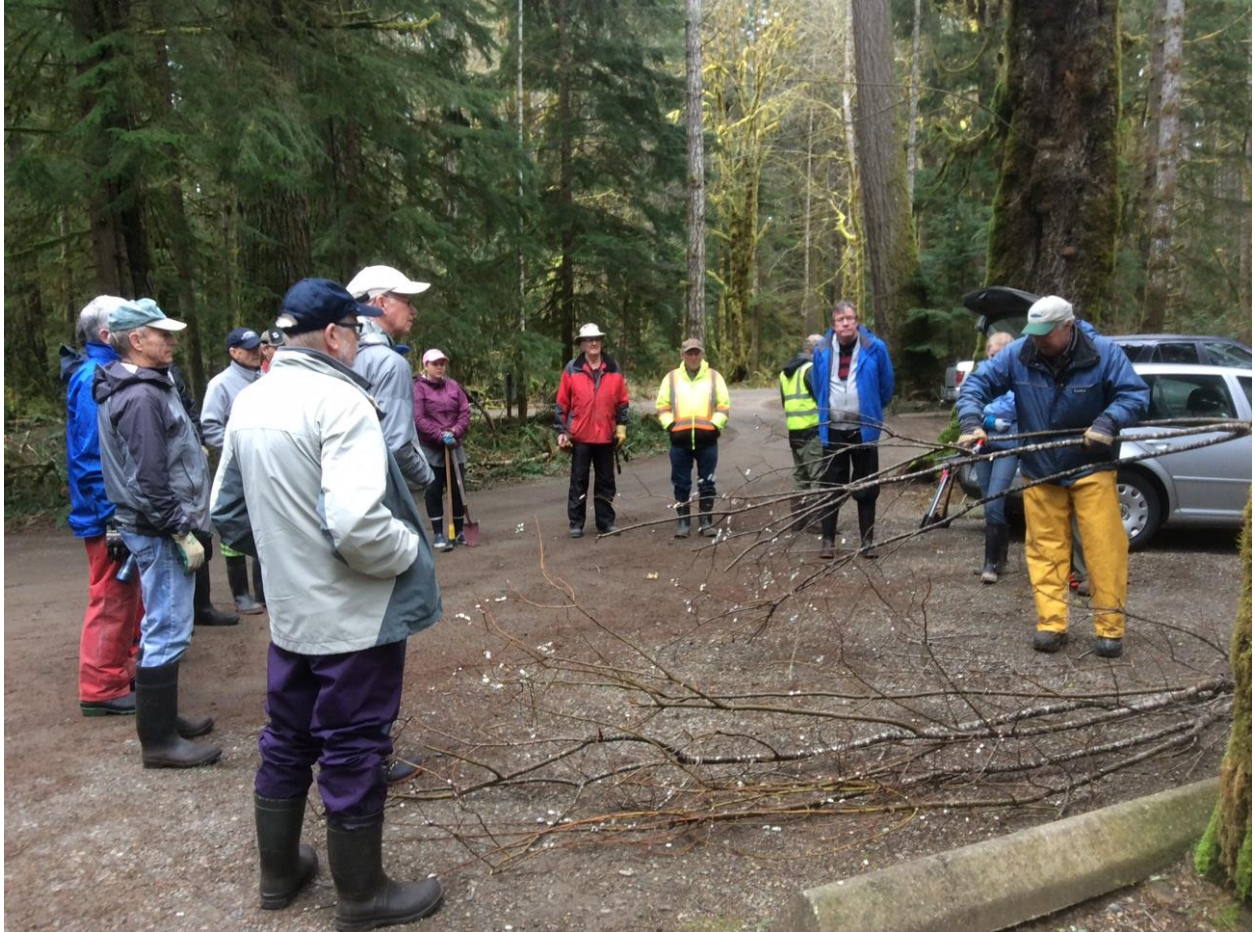
Demonstration of removing lateral branches from willow – cut close to main stem, continue along stem as long as diameter is >1 inch. Cut above branch forks.

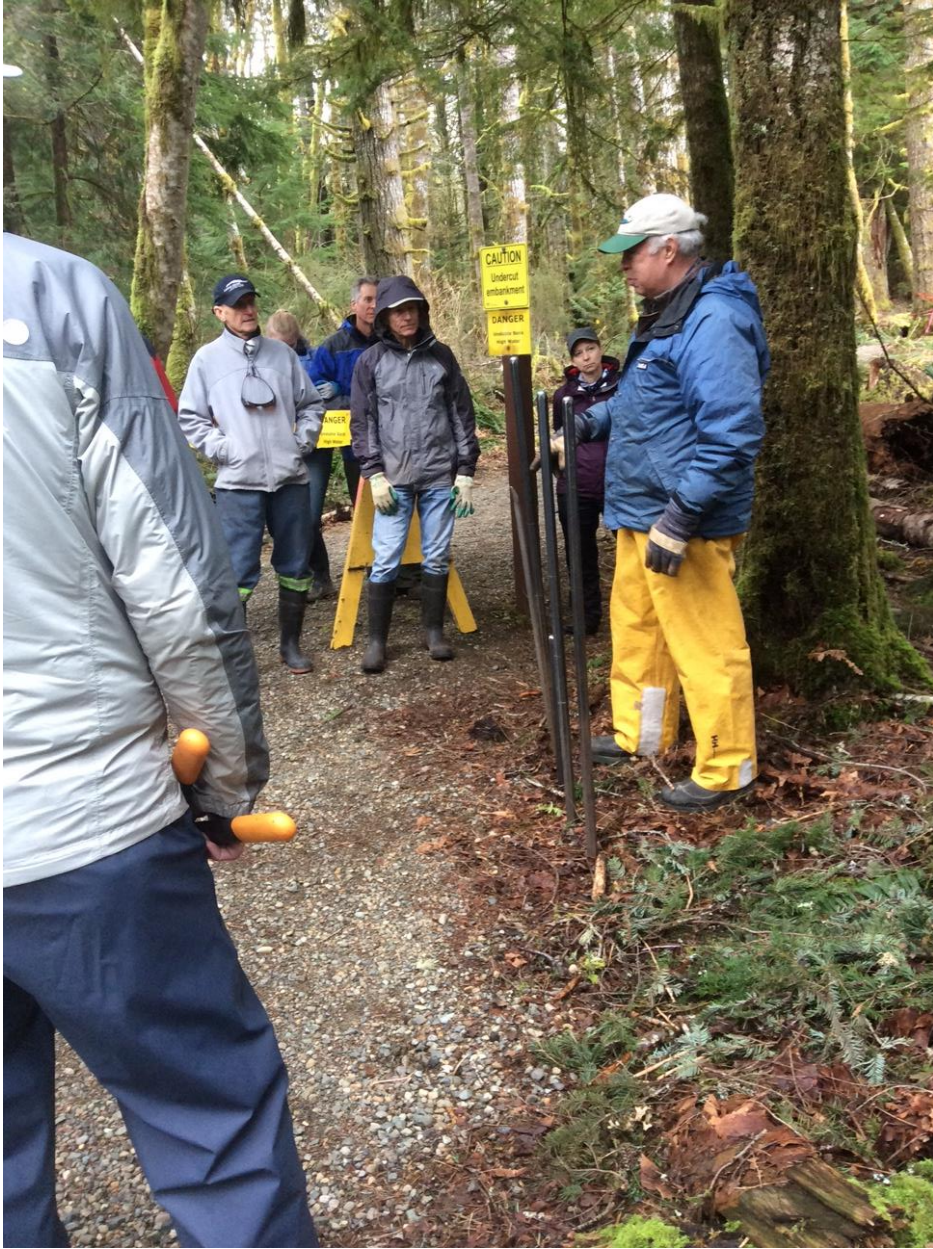
Dave Polster showing hexagonal planting bars.

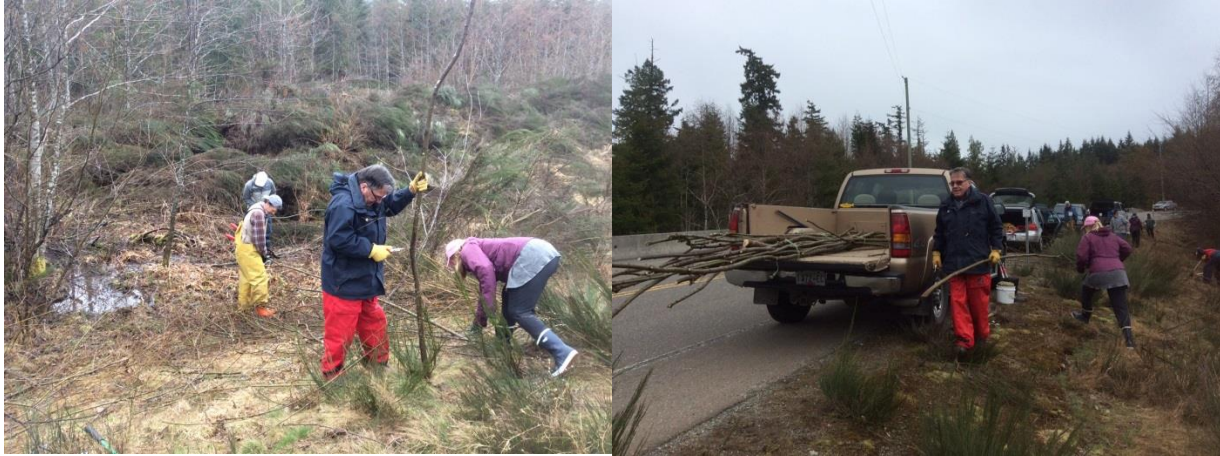
Harvesting live willow stakes along the Cook Creek Road ROW. Live willow stakes had all side branches cut as close to the main stem as possible and live stake segments were ideally  $>1.5$  m long or longer. Lengths were cut just above forks and at locations where stem diameters were  $>1$  inch. Bundles of approx. 10 live stakes were tied together with biodegradable (non-plastic) twine.

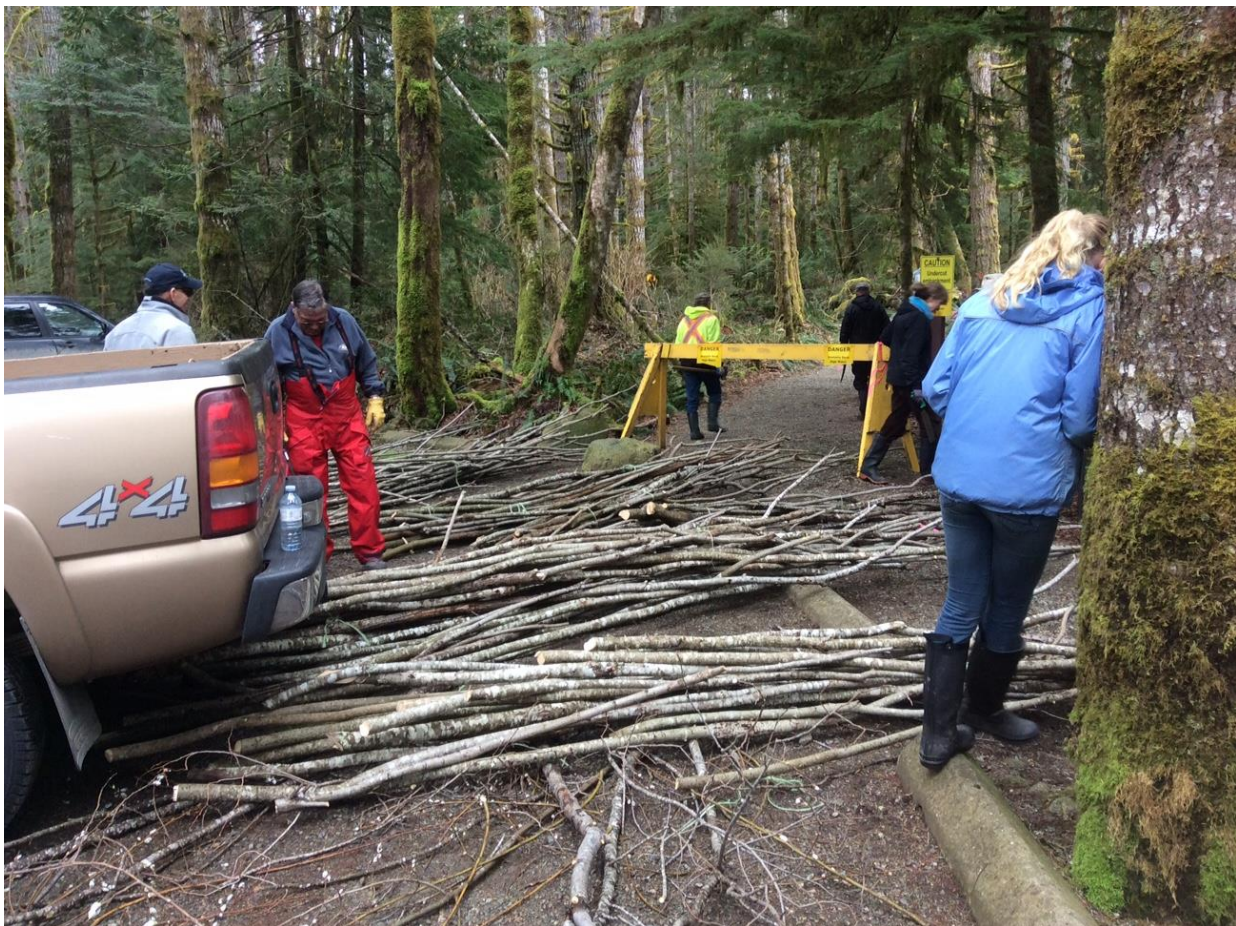
Unloading live willow stakes for riparian restoration work in Rosewall Creek parking lot area. Live stakes were sharpened (using an axe) so that they could be driven into the ground more easily.

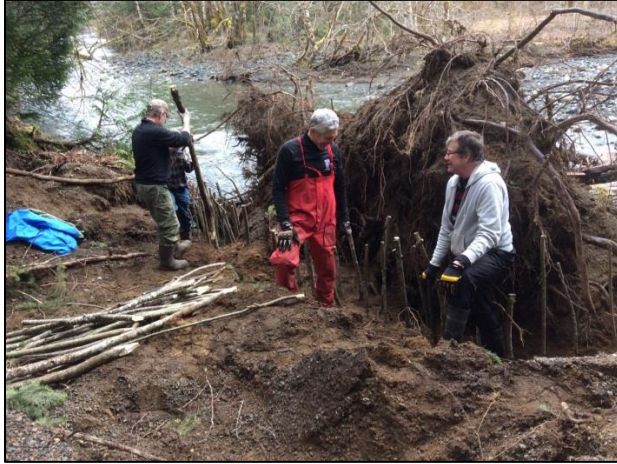
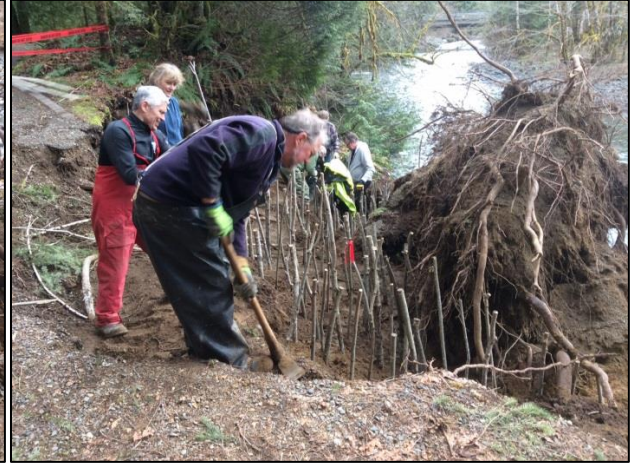
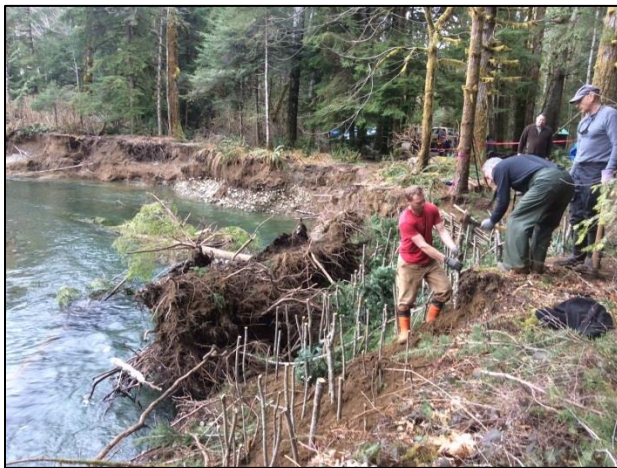
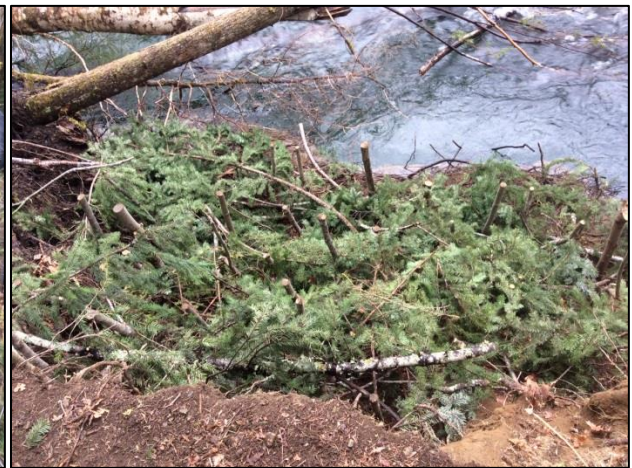
Progression of dense live staking on stream bank behind fallen trees as a means to stabilize the bank and retain LWD instream. Live willow stakes were planted in holes made by hexagonal planting bars. The amount of depth for live stakes was 1 m into the ground and 1 m above ground. Sledge hammers were used to drive sharpened stakes into the ground. Ensure stakes are oriented with leaf scars as 'happy faces'.

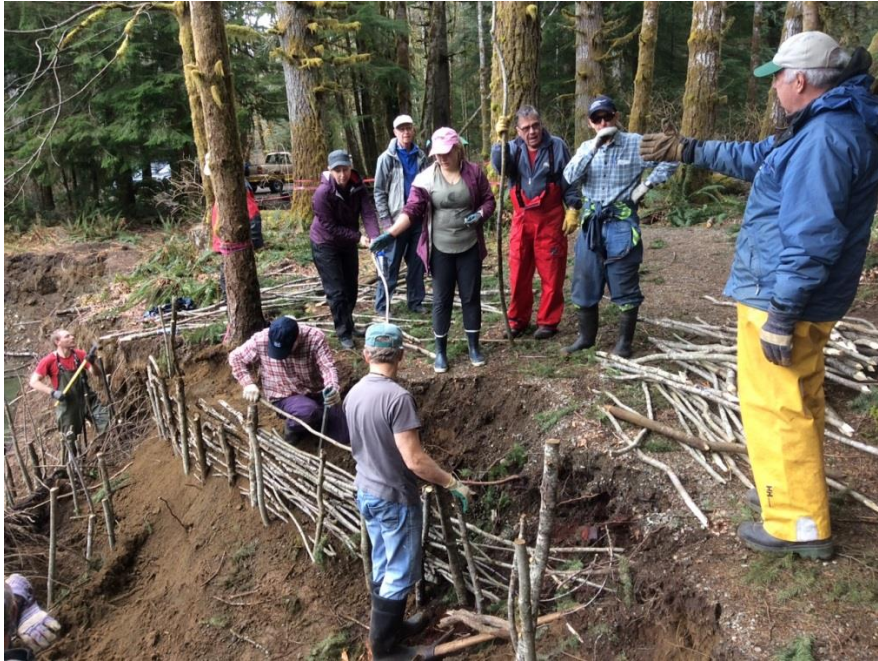
Wattle fencing was used to support the bank in one location. Larger diameter, sharpened live stakes were driven into the ground and small diameter, flexible willow were woven along, alternating with soil. At the end of the fence, willow were turned in the opposite direction so their tops were reversed.

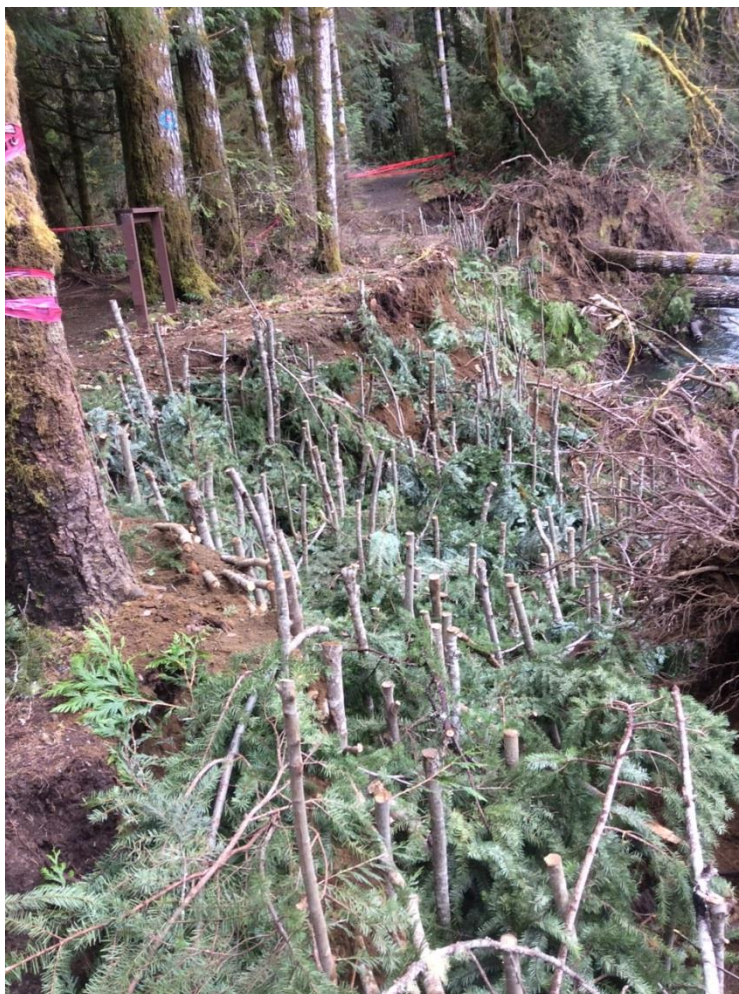
When dense live-staking and wattle fencing were complete, conifer boughs were placed between live stakes to prevent rain drop erosion of the steep bank soils.

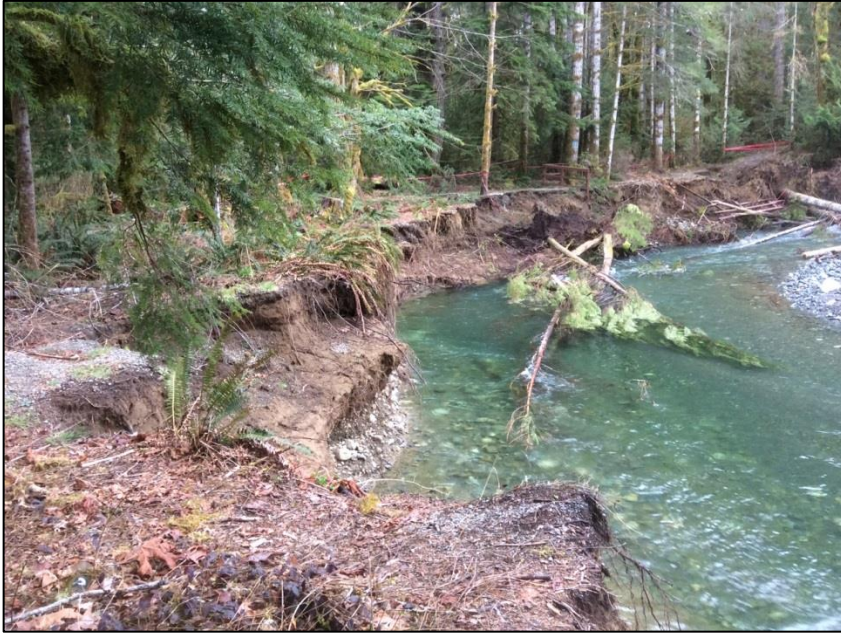
Rosewall Creek – before riparian restoration March 31, 2017

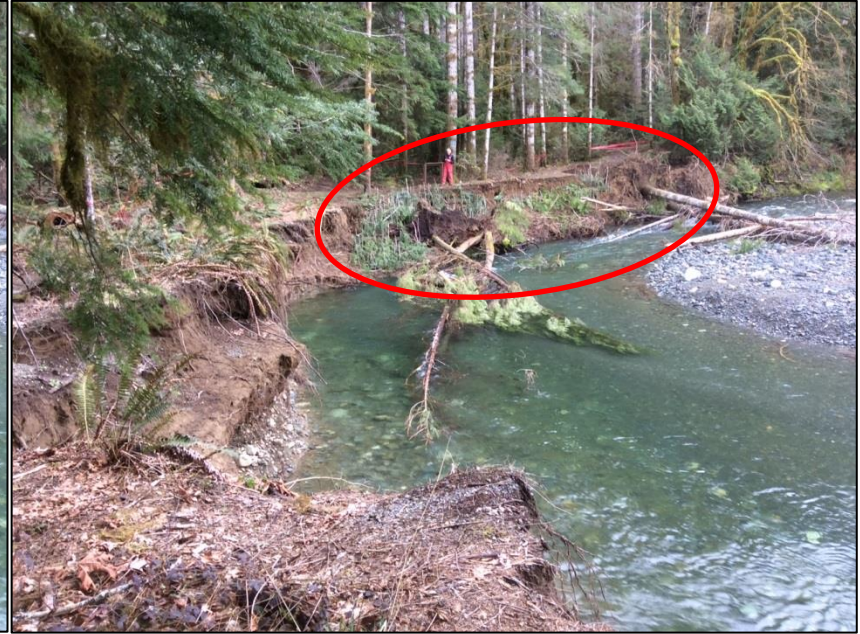
Rosewall Creek – after riparian restoration March 31, 2017
